Date: 20th September 2023

TECH TOOL RELEASE NOTES

Version 2.8.210

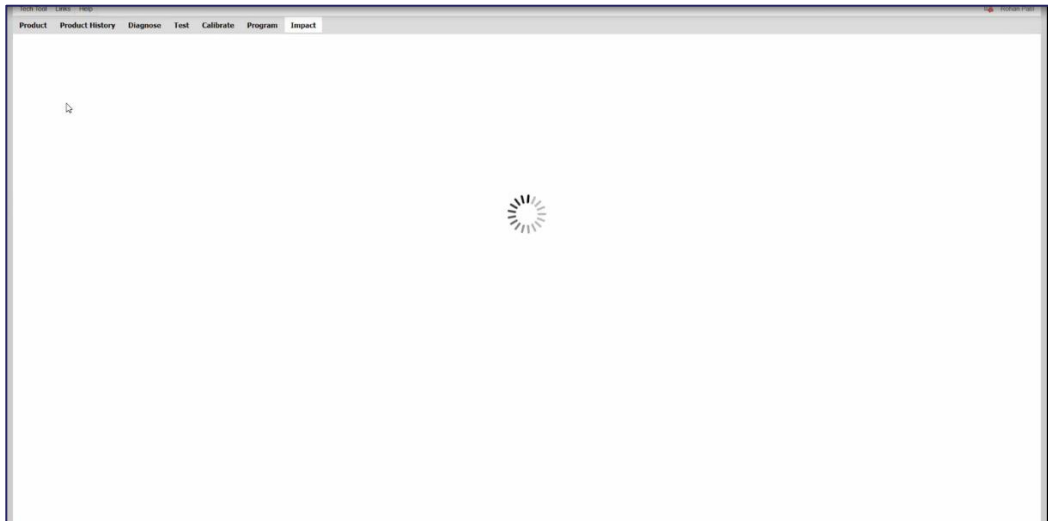
Issue-1: The Impact tab might not load and will be frozen.

Cause: Impact application.

Suggestion: Kindly follow the below steps:

1. Launch Impact tab standalone application from Browser.
2. Enter the chassis information and select "Repair" as Info Type.
3. Select "Titles" under Search by and enter the search criteria.

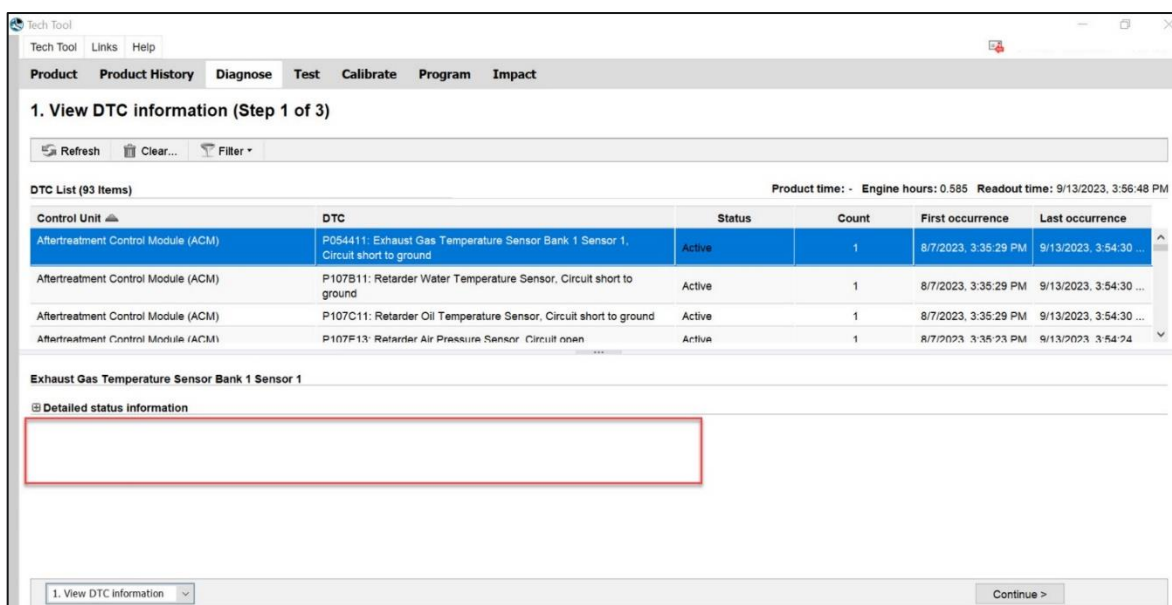
Issue-2: Freeze frame information is missing from Diagnose tab.

Cause: Under Investigation.

Suggestion: No workaround available.

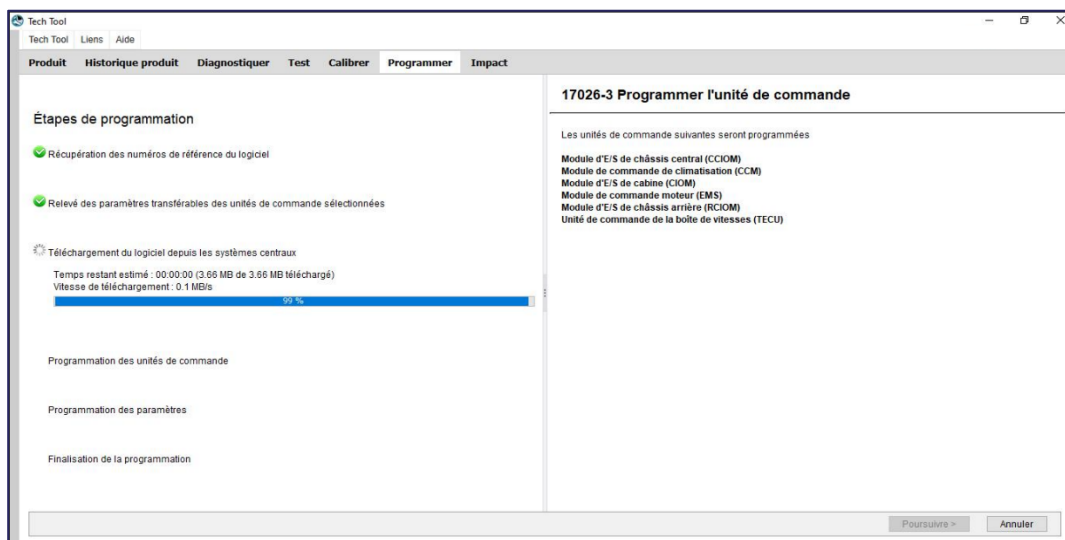
Issue-5: While programming, the software download might get stuck at 99%.

Cause: Under Investigation.

Suggestion: Use Quick Repair tool to resolve this issue. Refer [Video](#).
