**Date:** 02<sup>nd</sup> November 2023

# TECH TOOL RELEASE NOTES

**Version 2.8.220**

**Volvo Group**

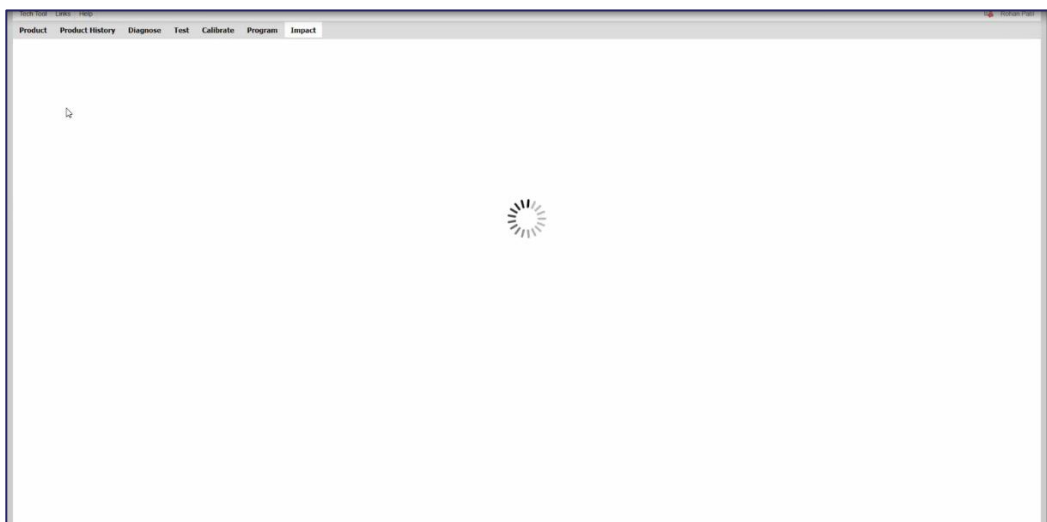
**Issue-1:** The Impact tab might not load and will be frozen.

**Cause:** Impact application.

**Suggestion:** Kindly follow the below steps:

1. Launch Impact tab standalone application from Browser.
2. Enter the chassis information and select "Repair" as Info Type.
3. Select "Titles" under Search by and enter the search criteria.

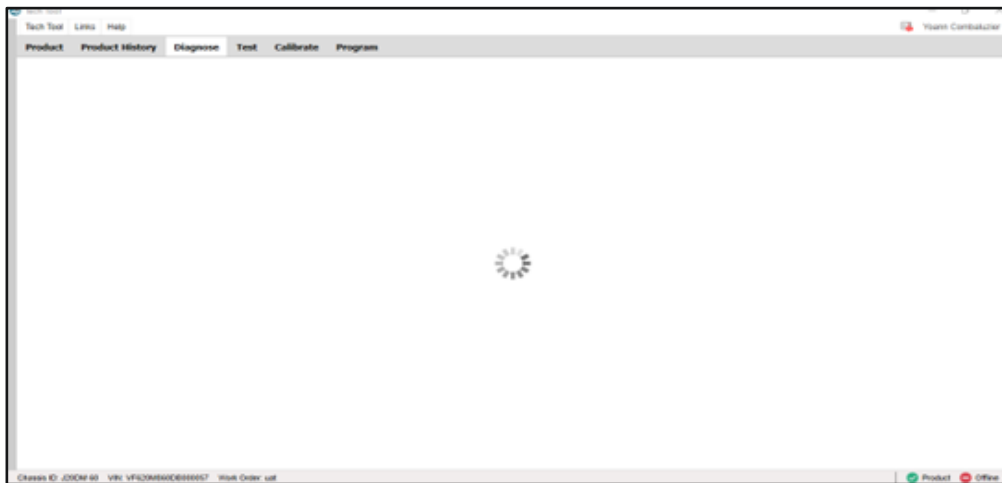
**Issue-2:** While switching between the tabs, Tech Tool might be frozen.

**Cause:** Under Investigation.

**Suggestion:** Kindly follow the below steps:

1. Ensure that there is a stable network as shown in the icon

2. Restart Tech Tool.
3. If not able to recover, restart the computer.

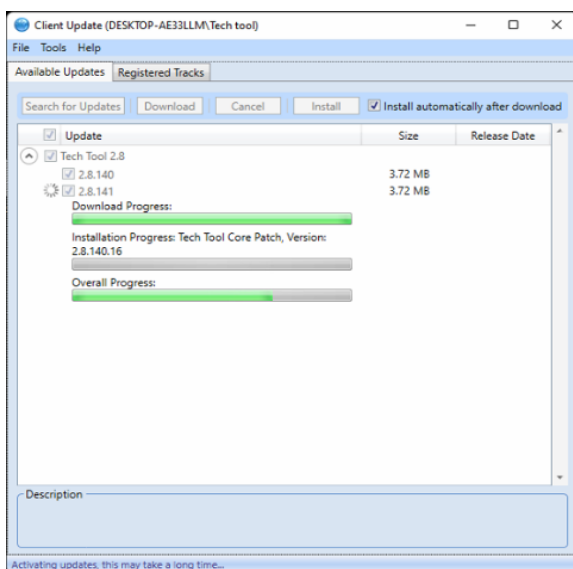
**Issue-3:** Tech Tool installation progress bar is frozen during Client Update.

**Cause:** Under Investigation.

**Suggestion:** Restart computer if the progress bar is frozen.

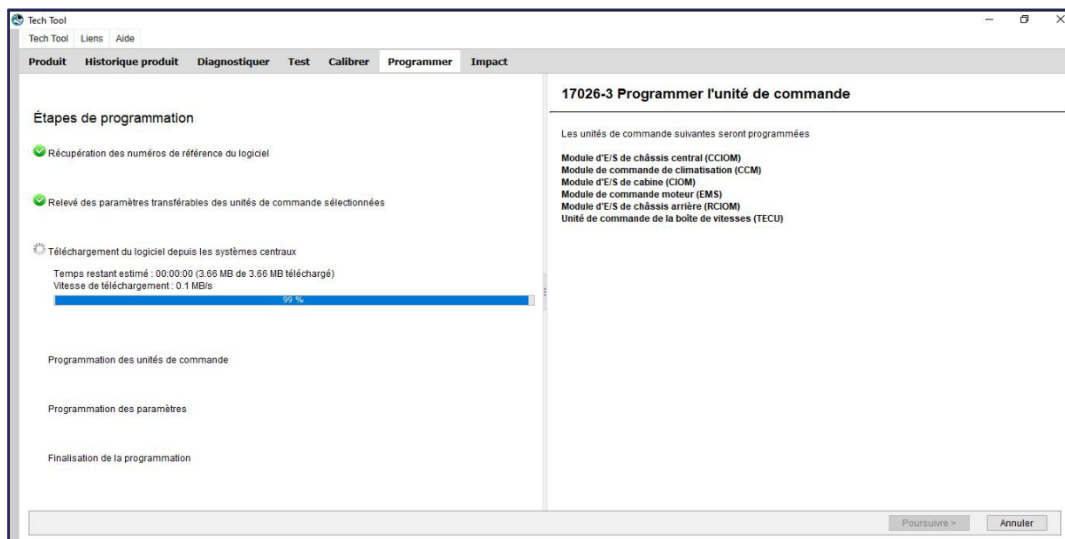
**Issue-4:** While programming, the software download might get stuck at 99%.

**Cause:** Under Investigation.

**Suggestion:** Use Quick Repair tool to resolve this issue. Refer [Video](#).
