Date: 16th November 2023

TECH TOOL RELEASE NOTES

Version 2.8.221

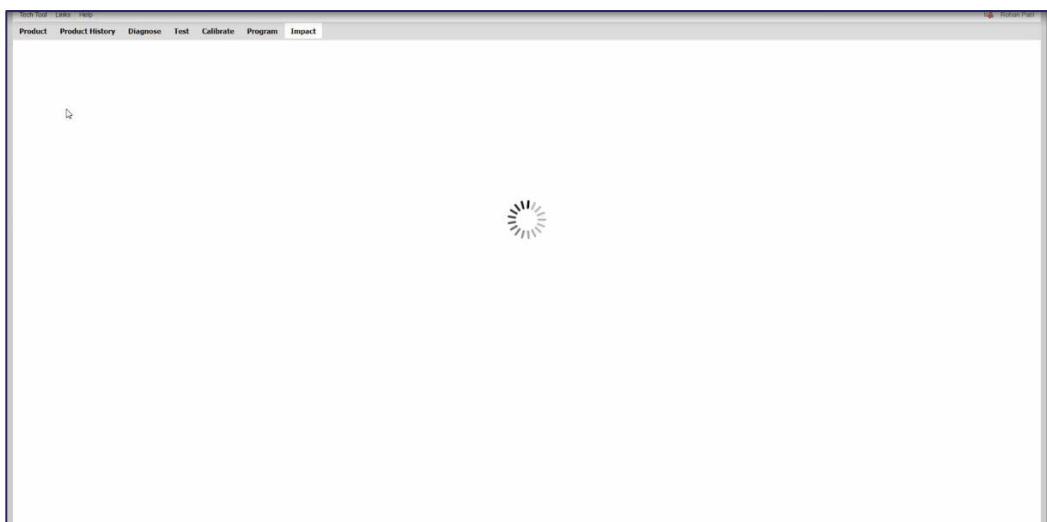
Issue-1: The Impact tab might not load and will be frozen.

Cause: Impact application.

Suggestion: Kindly follow the below steps:

1. Launch Impact tab standalone application from Browser.
2. Enter the chassis information and select "Repair" as Info Type.
3. Select "Titles" under Search by and enter the search criteria.

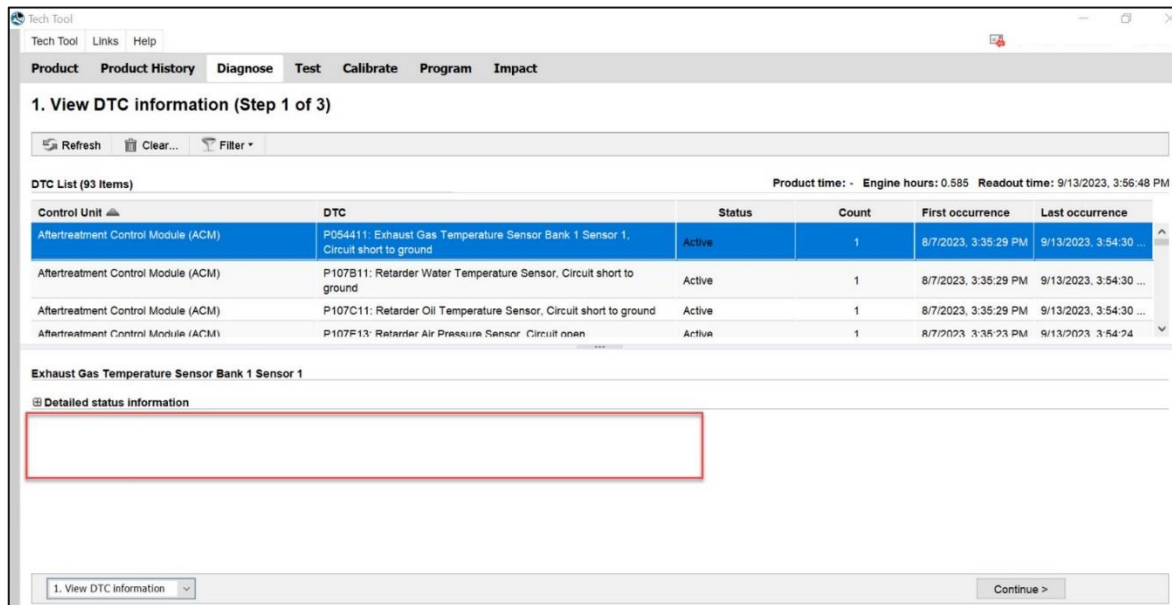
Issue-2: Freeze frame information is missing from Diagnose tab.

Cause: Under Investigation.

Suggestion: No workaround available.

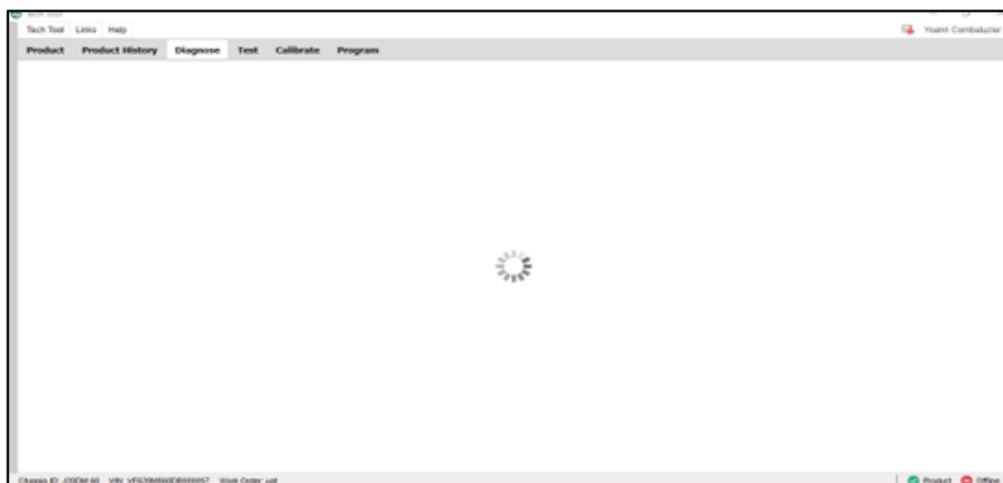
Issue-3: While switching between the tabs, Tech Tool might be frozen.

Cause: Under Investigation.

Suggestion: Kindly follow the below steps:

1. Ensure that there is a stable network as shown in the icon
2. Restart Tech Tool.
3. If not able to recover, restart the computer.

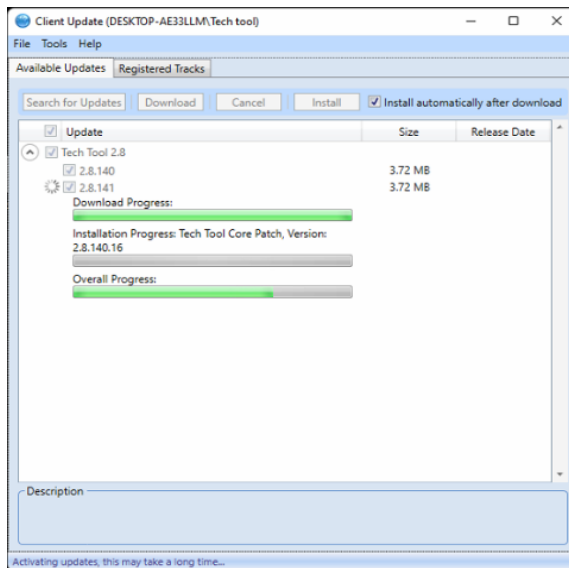
Issue-4: Tech Tool installation progress bar is frozen during Client Update.

Cause: Under Investigation.

Suggestion: Restart computer if the progress bar is frozen.

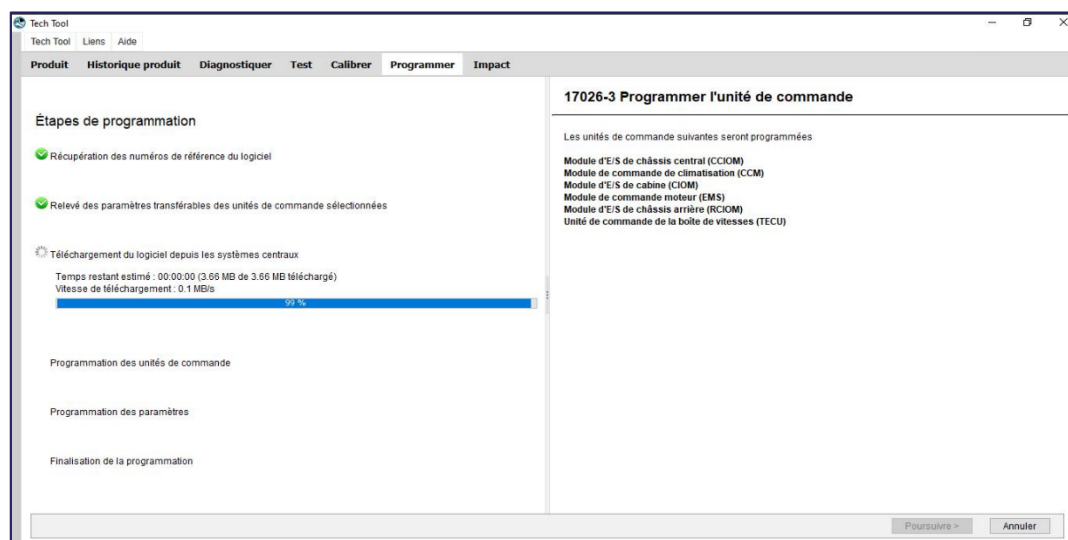
Issue-5: While programming, the software download might get stuck at 99%.

Cause: Under Investigation.

Suggestion: Use Quick Repair tool to resolve this issue. Refer [Video](#).
