**Date:** 11<sup>th</sup> December 2023

# TECH TOOL RELEASE NOTES

**Version 2.8.230**

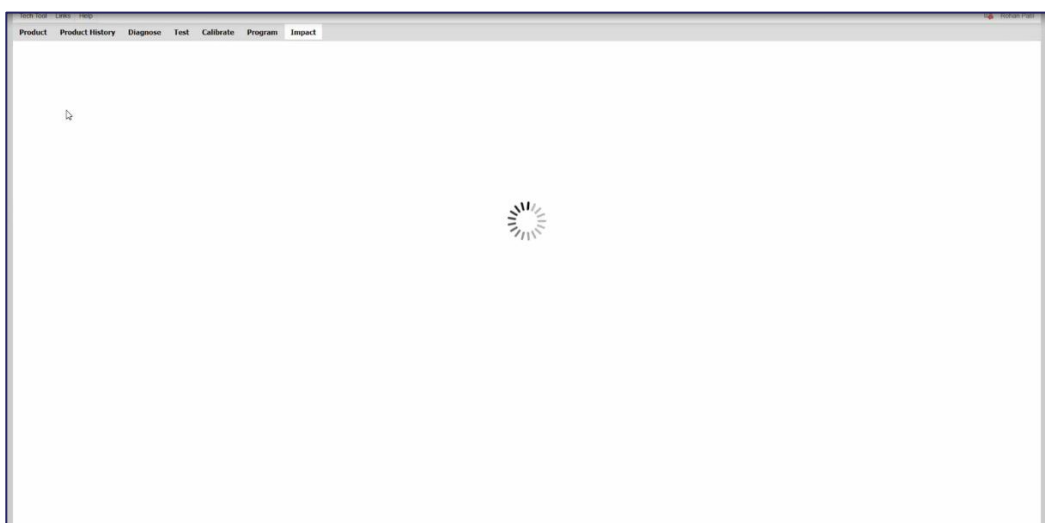
### **Issue-1:** The Impact tab might not load and will be frozen.

**Cause:** Impact application.

**Suggestion:** Kindly follow the below steps:

1. Launch Impact tab standalone application from Browser.
2. Enter the chassis information and select "Repair" as Info Type.
3. Select "Titles" under Search by and enter the search criteria.

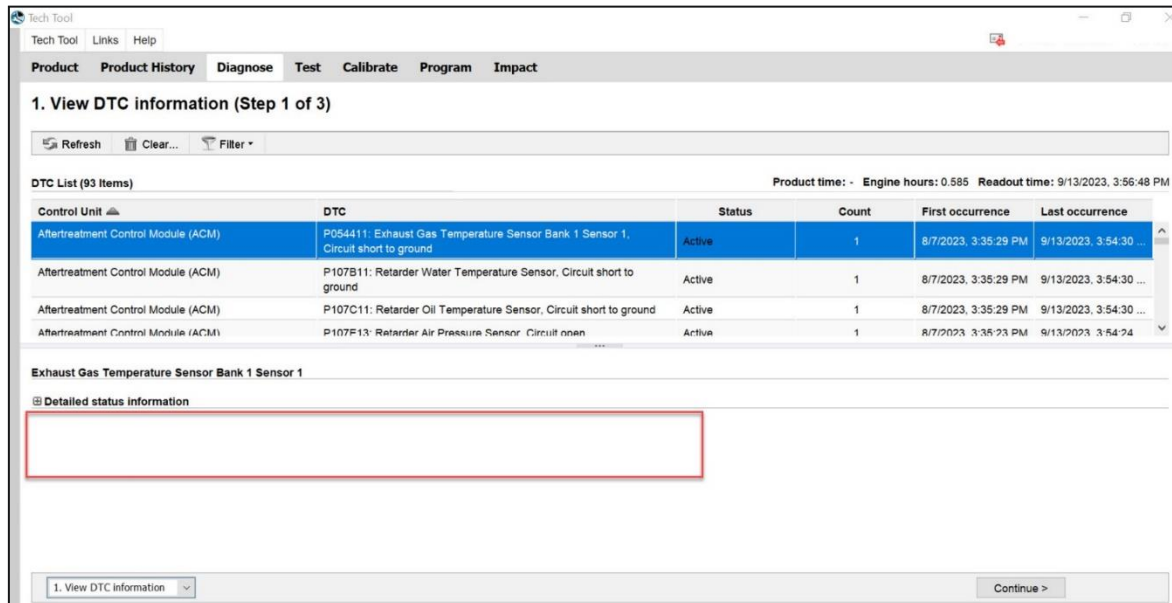
**Issue-2: Freeze frame information is missing from Diagnose tab.****Cause:** Under Investigation.

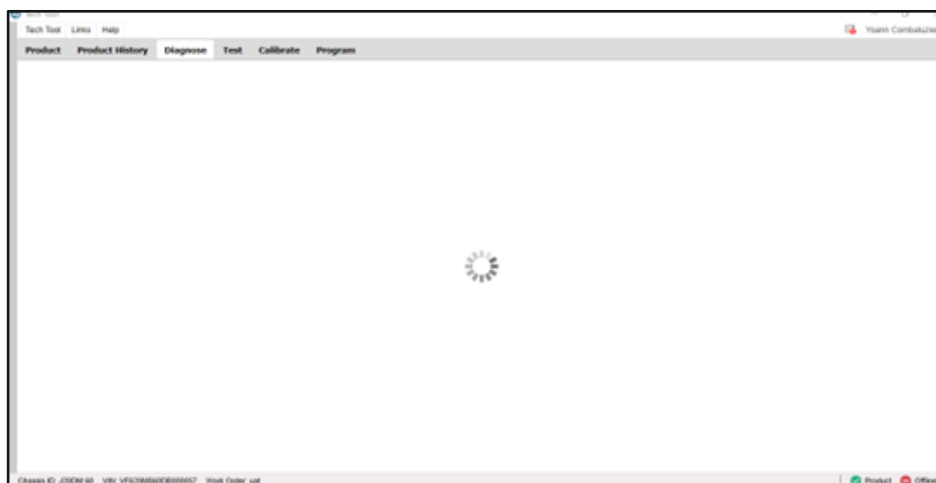
**Suggestion:** No workaround available.**Issue-3: While switching between the tabs, Tech Tool might be frozen.****Cause:** Under Investigation.

**Suggestion:** Kindly follow the below steps:

1. Ensure that there is a stable network as shown in the icon
2. Restart Tech Tool.
3. If not able to recover, restart the computer.

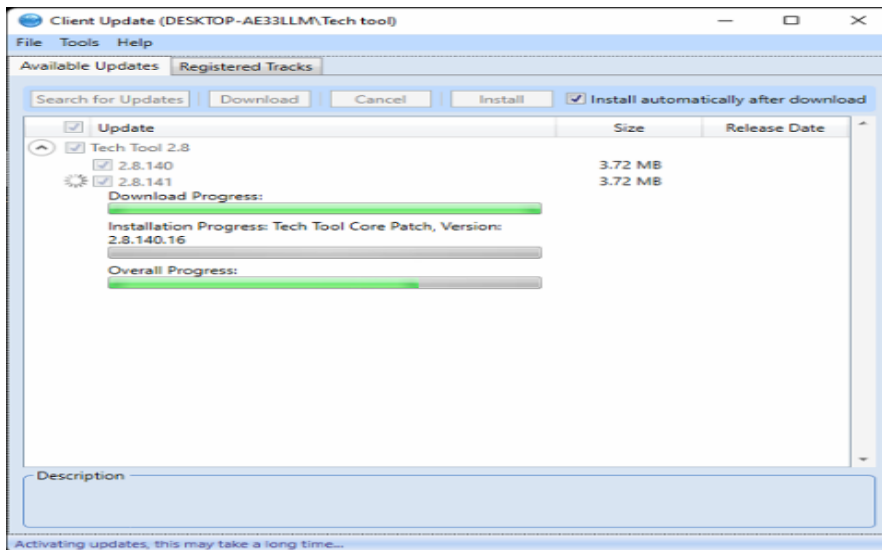
## **Issue-4:** Tech Tool installation progress bar is frozen during Client Update.

**Cause:** Under Investigation

**Suggestion:** Restart computer if the progress bar is frozen.

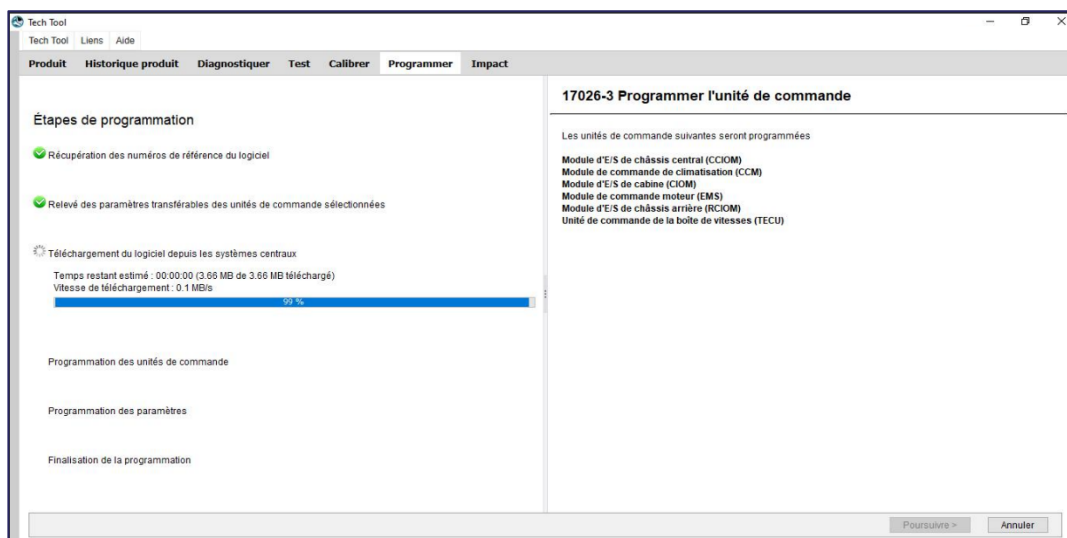
## **Issue-5:** While programming, the software download might get stuck at 99%.

**Cause:** Under Investigation.

**Suggestion:** Use Quick Repair tool to resolve this issue. Refer [Video](#).
